**Flood Control Project Maintenance  
Levee Inspections**

**Maintenance Issue Types Only, Levee Inspection Report By Mile - Fall 2018**

**Reclamation District No. 0150 Merrit Island**

Waterway	Bank	Unit Miles	Inspection Start/End	Inspector
Unit No. 01 Sutter Slough	Left	0.52	11/09/2018 11/09/2018	Luz Dial

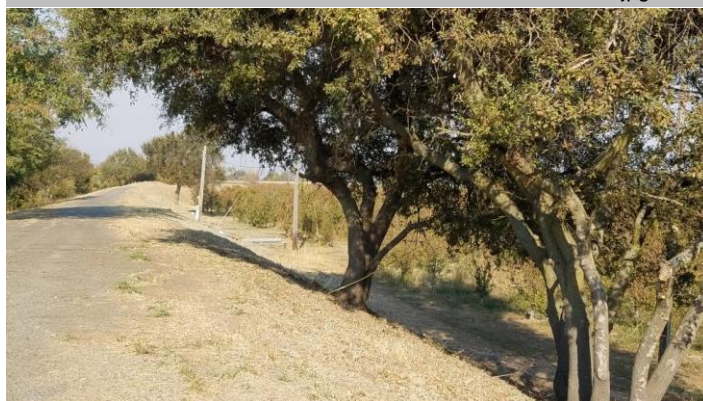
Photo 1 of 1 : FA\_2018\_RD0150\_15\_1\_20181115\_00002.jpg

LM Start	0.00	Rating **	A	Issue No.	1
LM End	0.48	Issue Type +	Ma	Location *	LS
Category	Earthen Levee			GPS Latitude/Longitude	
				Start	End
Item	Vegetation			38.332642 °	38.328362 °
				-121.583471 °	-121.576783 °
DWR ID	DWR_RD0150_01_f_2018_1				
Comment Code					
V1 : Control annual grass and weeds on the levee slopes and easements.					
Inspector Comment					
Annual vegetation is maintained.

View of landside vegetation. Fall 2018

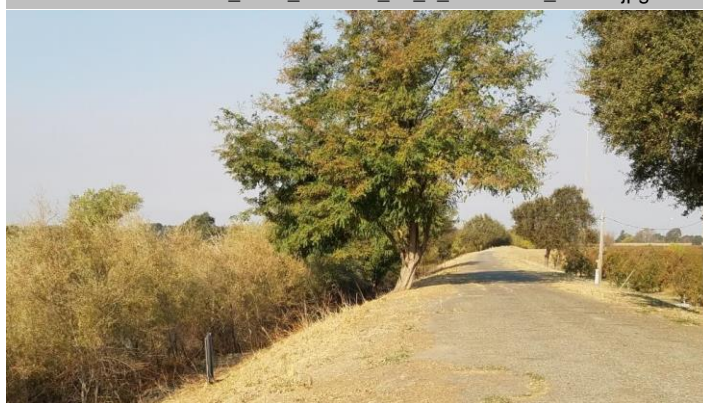
Photo 1 of 1 : FA\_2018\_RD0150\_15\_2\_20181115\_00001.jpg

LM Start	0.00	Rating **	A	Issue No.	2
LM End	0.48	Issue Type +	Ma	Location *	WS
Category	Earthen Levee			GPS Latitude/Longitude	
				Start	End
Item	Vegetation			38.332642 °	38.328362 °
				-121.583471 °	-121.576783 °
DWR ID	DWR_RD0150_01_f_2018_2				
Comment Code					
V1 : Control annual grass and weeds on the levee slopes and easements.					
Inspector Comment					
Annual vegetation is maintained.

View of waterside vegetation. Fall 2018

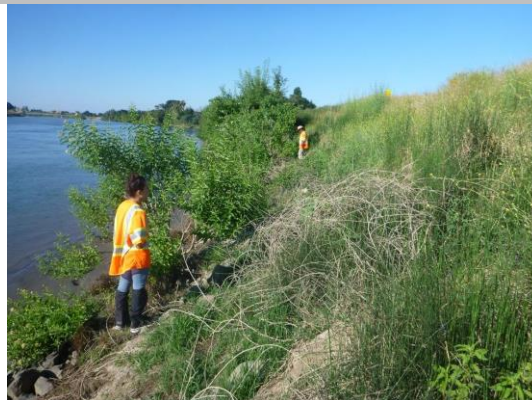
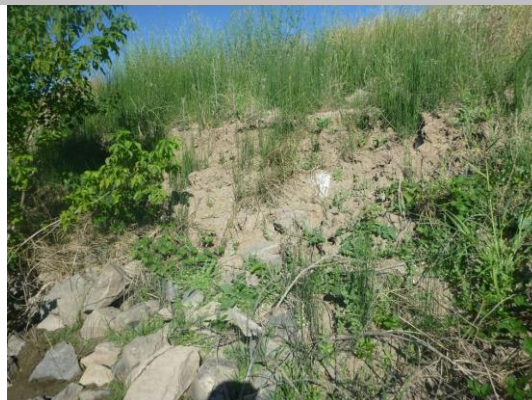
LM Start	0.11	Rating **	A/W	Issue No.	46
LM End	0.14	Issue Type +	Ma	Location *	WS
Category	Supplemental			GPS Latitude/Longitude	
				Start	End
Item	2017 Storm Damage			38.329369 °	38.329767 °
				-121.574936 °	-121.574589 °
DWR ID	DWR_RD0150_02_f_2017_46				
Comment Code

Description: The flood damage consists of a waterside erosion approximately 185 feet long on the west (right) bank of the Sacramento River. See attached pages for photos.

Notes: Crown is a paved road. Scarps upto 3 ft deep, not fully vertical though. Area of concern because erosion is not very deep into prism.

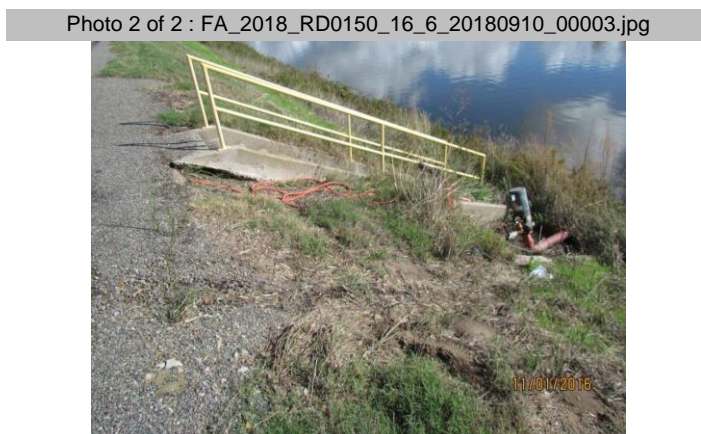
LM Start	0.38	Rating **	M	Issue No.	6
LM End	0.38	Issue Type +	Ma	Location *	WS
Category	Earthen Levee			GPS Latitude/Longitude	
				Start	End
Item	Slope Stability			38.332598°	38.332598°
				-121.572179°	-121.572179°
DWR ID	DWR_RD0150_02_s_2012_6				
Comment Code					
S2 : Repair the levee slope damaged by foot traffic and prevent access where possible.					
Inspector Comment

View of slope instability on the waterside of the levee. Fall 2016

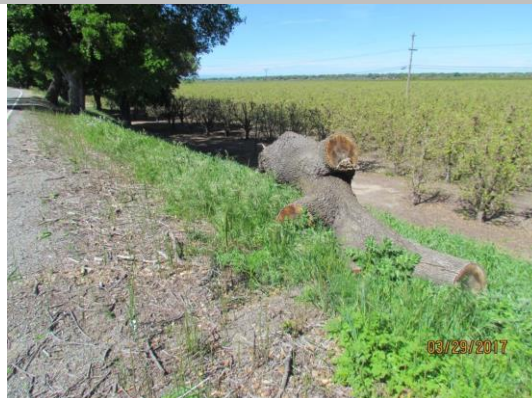
Photo 1 of 1 : FA\_2018\_RD0150\_16\_63\_20180910\_00043.jpg

LM Start	2.10	Rating **	M	Issue No.	63
LM End	2.10	Issue Type +	Ma	Location *	LS
Category	Earthen Levee			GPS Latitude/Longitude	
				Start	End
Item	Encroachments			38.347002°	38.347002°
				-121.547803°	-121.547803°
DWR ID	DWR_RD0150_02_f_2016_63				
Comment Code					
TR : Tree or limb					
Inspector Comment

View of a tree trunk on the landside slope of the levee. Spring 2017

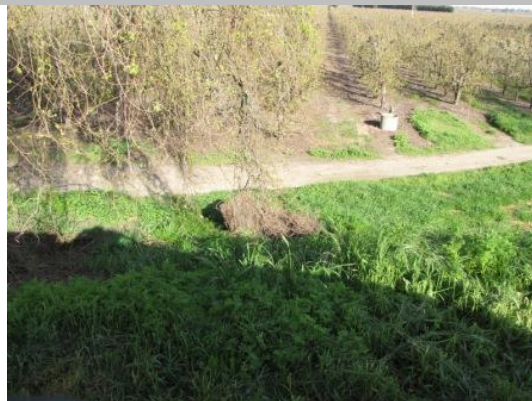
Photo 1 of 1 : FA\_2018\_RD0150\_16\_14\_20180910\_00009.jpg

LM Start	2.75	Rating **	N	Issue No.	14
LM End	2.75	Issue Type +	Ma	Location *	LS
Category	Earthen Levee			GPS Latitude/Longitude	
				Start	End
Item	Trim / Thin Trees			38.350041 °	38.350041 °
				-121.536853 °	-121.536853 °
DWR ID	DWR_RD0150_02_s_2012_14				
Comment Code					
T5 : Tree stumps.					
Inspector Comment

View of a tree stump on the landward slope.

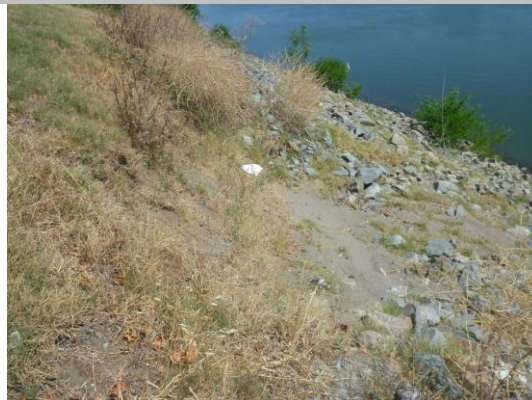
Photo 4 of 4 : LEVAL\_FA\_2018\_289\_2168.jpg

Item	2017 Storm Damage			38.405933 °	38.406722 °	
				-121.517197 °	-121.517617 °	
DWR ID	DWR_RD0150_02_f_2017_53					
Comment Code						
Inspector Comment						
Levee Evaluation Comments						
Description:The flood damage consists of a waterside erosion approximately 311 feet long on the west (right) bank of the Sacramento River. See attached pages for photos.						
Site ID No:289						
Site Designation:LMA-115						
Repair Type: Erosion						
Rating:Area of Concern						
Field Date:7/17/2017						
Notes: Crown is a paved road. 2 scarps 6 ft deep and about 15 ft long each within site and 6 ft from crown, otherwise erosion was pretty small. Rip rap on 3/4 of slope here, but not full coverage. Area of concern because deeper scarps only extended a short distance.

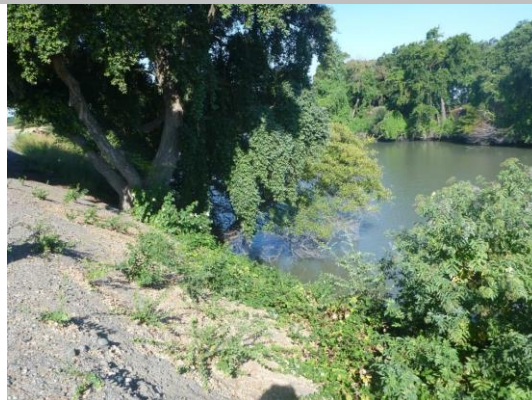
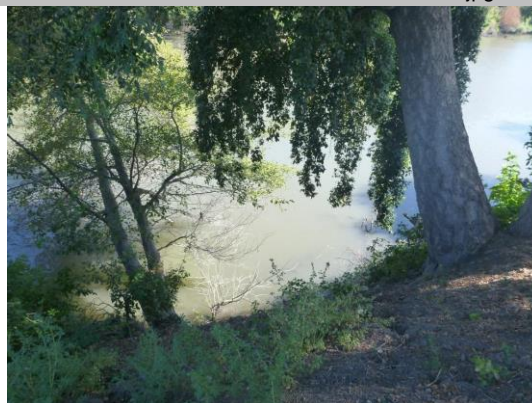
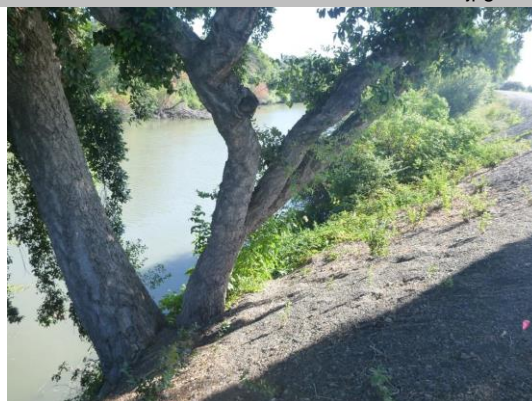
LM Start	2.29	Rating **	A/W	Issue No.	37 (cont)
LM End	2.30	Issue Type +	Ma	Location *	WS
Category	Supplemental			GPS Latitude/Longitude	
				Start	End
Item	2017 Storm Damage			38.354103°	38.354211°
				-121.564850°	-121.564631°
DWR ID	DWR_RD0150_03_f_2017_37				
Comment Code					
Inspector Comment					
Levee Evaluation Comments					
Description:Instability, cracking, and erosion were observed on the waterside levee slope on the east (left) bank of Elk Slough. The site is approximately 75 feet long. See attached pages for photos.					
Site ID No:294					
Site Designation:LMA-120					
Repair Type: Erosion					
Rating:Area of Concern					
Field Date:7/19/2017					
Notes: Area of concern because erosion is not too far into the levee prism and looks similar to the rest of the levee outside of the site.					
Crown is a paved road.

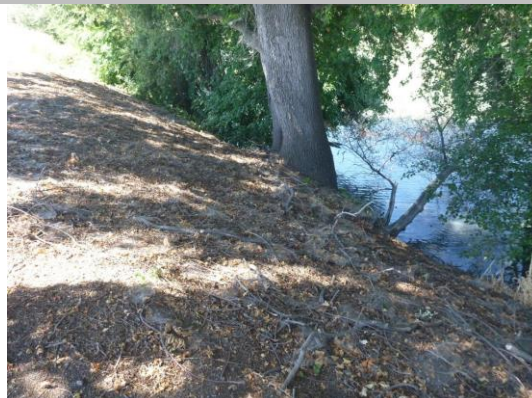
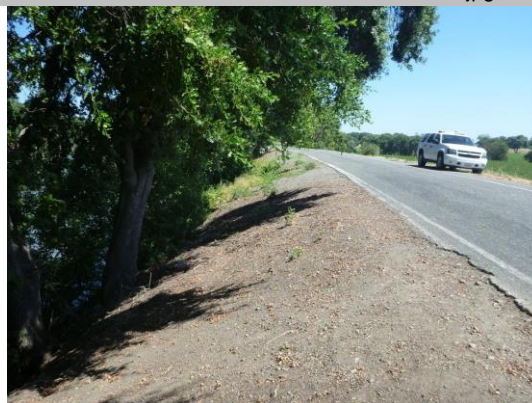
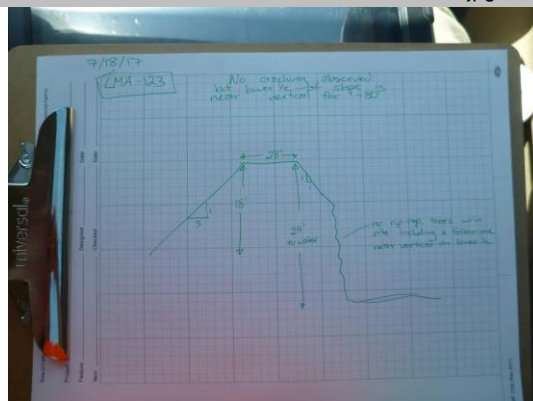
Comment Code					
Inspector Comment					
Levee Evaluation Comments					
Description:On 11 and 15 January 2017, waterside instability and cracking were observed on the east (left) bank of Elk Slough. The site is approximately 75 feet long and 5 to 10 feet down from the levee crest. See attached pages for photos					
Site ID No:297					
Site Designation:LMA-123					
Repair Type: Stability					
Rating:Area of Concern					
Field Date:7/18/2017					
Notes: Crown is a paved road. 20 ft of cracking observed maximum within the site, but lower 1/4 of slope is near vertical. Lower priority because it is not too much worse than the surrounding levees.

Item	2017 Storm Damage		38.359256°	38.359461°								
			-121.561239°	-121.561275°								
DWR ID	DWR_RD0150_03_f_2017_42											
Comment Code												
Inspector Comment												
<p>Levee Evaluation Comments</p> <p>Description: On 11 and 15 January 2017, waterside instability and cracking were observed on the east (left) bank of Elk Slough. The site is approximately 75 feet long and 5 to 10 feet down from the levee crest. See attached pages for photos</p> <p>Site ID No: 297</p> <p>Site Designation: LMA-123</p> <p>Repair Type: Stability</p> <p>Rating: Area of Concern</p> <p>Field Date: 7/18/2017</p> <p>Notes: Crown is a paved road. 20 ft of cracking observed maximum within the site, but lower 1/4 of slope is near vertical. Lower priority because it is not too much worse than the surrounding levees.</p>

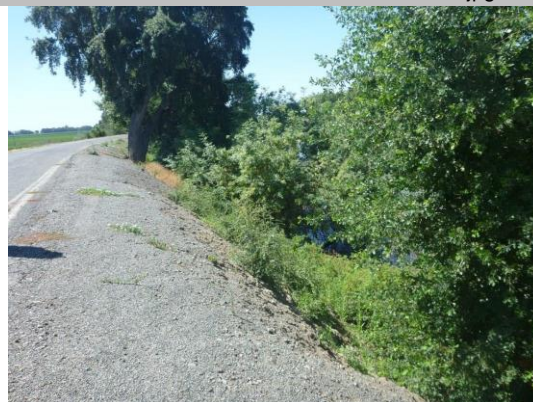
Photo 1 of 3 : LEVAL\_FA\_2018\_298\_1924.jpg

Item	2017 Storm Damage		38.359594°	38.359808°								
			-121.561308°	-121.561369°								
DWR ID	DWR_RD0150_03_f_2017_45											
Comment Code												
Inspector Comment												
<p>Levee Evaluation Comments</p> <p>Description: On 11 and 15 January 2017, waterside instability and cracking were observed on the east (left) bank of Elk Slough. The site is approximately 80 feet long and 5 to 10 feet down from the levee crest. See attached pages for photos.</p> <p>Site ID No: 298</p> <p>Site Designation: LMA-124</p> <p>Repair Type: Stability</p> <p>Rating: Area of Concern</p> <p>Field Date: 7/18/2017</p> <p>Notes: No cracking observed, but there is runoff erosion along the entire WS slope here. Crown is a paved road. Area of concern because erosion was caused by runoff and was less severe than other sites along Elk Slough.</p>

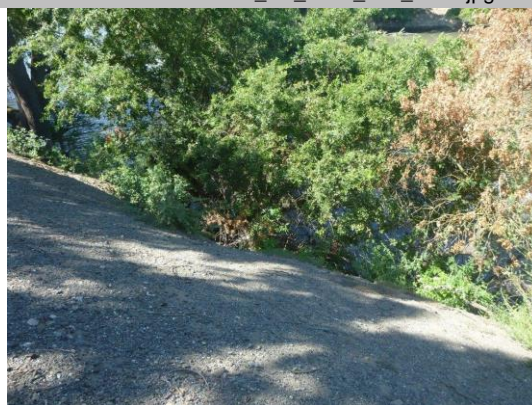
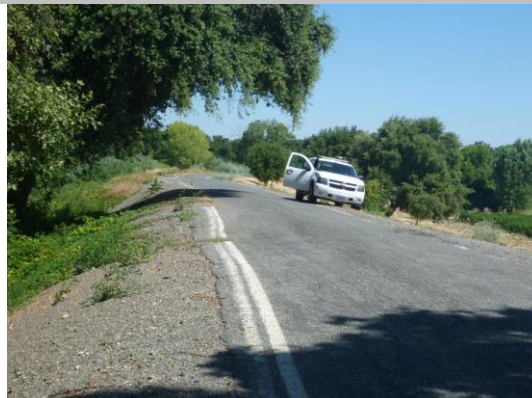
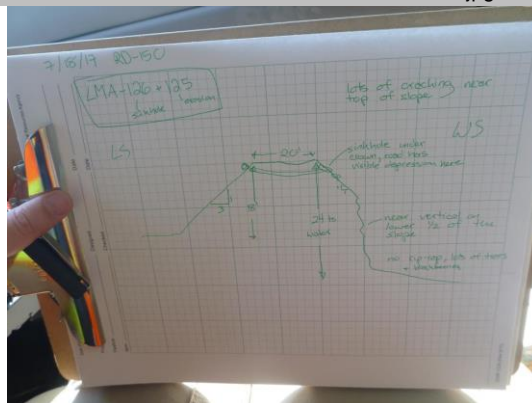
LM Start	2.80	Rating **	A/W	Issue No.	53
LM End	2.81	Issue Type +	Ma	Location *	WS
Category	Supplemental			GPS Latitude/Longitude	
				Start	End
Item	2017 Storm Damage			38.360367 °	38.360544 °
				-121.561592 °	-121.561683 °
DWR ID	DWR_RD0150_03_f _ 2017_53				
Comment Code					
Inspector Comment					
Levee Evaluation Comments					
Description:On 11 January 2017, waterside instability and cracking were observed on the east (left) bank of Elk Slough. The site is approximately 70 feet long and 12 feet down from the levee crest. See attached pages for photos					
Site ID No:299					
Site Designation:LMA-125					
Repair Type: Stability					
Rating:Area of Concern					
Field Date:7/18/2017					
Notes: Crown is a paved road. Cracking on upper 1/3 of slope. Lower 1/2 of slope is near vertical. Area of concern because erosion is less severe than other sites along Elk Slough.

LM Start	2.80	Rating **	A/W	Issue No.	53 (cont)
LM End	2.81	Issue Type +	Ma	Location *	WS
Category	Supplemental			GPS Latitude/Longitude	
				Start	End
Item	2017 Storm Damage			38.360367°	38.360544°
				-121.561592°	-121.561683°
DWR ID	DWR_RD0150_03_f_2017_53				
Comment Code					
Inspector Comment					
Levee Evaluation Comments					
Description:On 11 January 2017, waterside instability and cracking were observed on the east (left) bank of Elk Slough. The site is approximately 70 feet long and 12 feet down from the levee crest. See attached pages for photos					
Site ID No:299					
Site Designation:LMA-125					
Repair Type: Stability					
Rating:Area of Concern					
Field Date:7/18/2017					
Notes: Crown is a paved road. Cracking on upper 1/3 of slope. Lower 1/2 of slope is near vertical. Area of concern because erosion is less severe than other sites along Elk Slough.

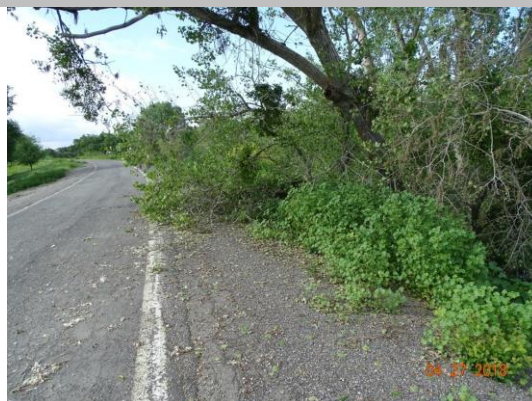
Photo 1 of 1 : FA\_2018\_RD0150\_17\_86\_20180910\_00081.jpg

LM Start	2.95	Rating **	M	Issue No.	86
LM End	2.95	Issue Type +	Ma	Location *	WS
Category	Earthen Levee			GPS Latitude/Longitude	
				Start	End
Item	Encroachments			38.362431 °	38.362431 °
				-121.562265 °	-121.562265 °
DWR ID	DWR_RD0150_03_s_2018_86				
Comment Code					
TR : Tree or limb					
Inspector Comment					
Remove downed tree on waterside slope.

Downed tree waterside looking southwest. Spring 2018

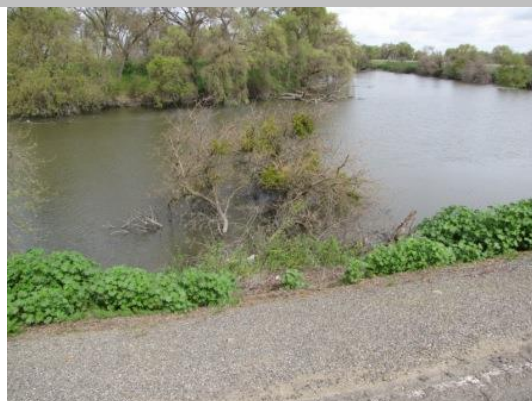
Photo 1 of 1 : FA\_2018\_RD0150\_17\_27\_20180910\_00009.jpg

LM Start	3.34	Rating **	M	Issue No.	27
LM End	3.34	Issue Type +	Ma	Location *	WS
Category	Earthen Levee			GPS Latitude/Longitude	
				Start	End
Item	Encroachments			38.363147 °	38.363147 °
				-121.556190 °	-121.556190 °
DWR ID	DWR_RD0150_03_s_2012_27				
Comment Code					
TR : Tree or limb					
Inspector Comment					
Downed tree on the waterside toe of the levee.

View of downed tree on the waterside slope looking upstream.

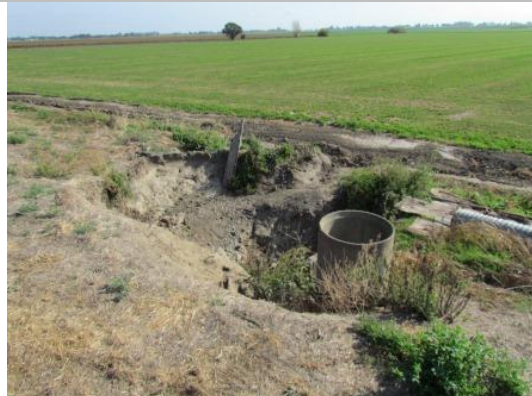
Photo 3 of 3 : FA\_2018\_RD0150\_17\_115\_20180910\_00113.jpg

LM Start	3.39	Rating **	U	Issue No.	115 (cont)	
LM End	3.39	Issue Type +	Ma	Location *	LS	
Category	Earthen Levee			GPS Latitude/Longitude		
				Start		End
Item	Erosion / Bank Caving			38.363540 °	38.363540 °	
				-121.555554 °	-121.555554 °	
DWR ID	DWR_RD0150_03_f_2013_115					
Comment Code						
E2 : Schedule repair of erosion site prior to the next inspection.						
Inspector Comment						
Erosion (ditch) was found on the landside toe of the levee.

A drainage ditch with depth of 4 feet and width of 15 feet was found on the landside toe of the levee. The picture was taken from the landside slope looking upstream during the fall 2013 inspection.

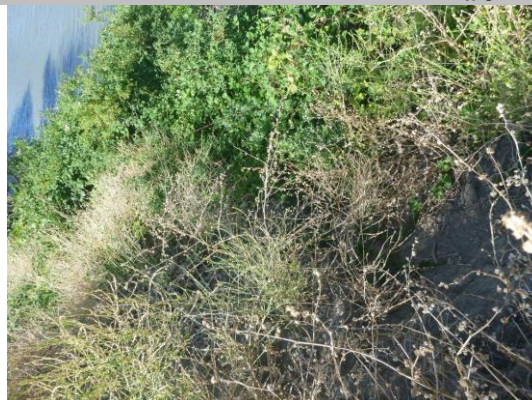
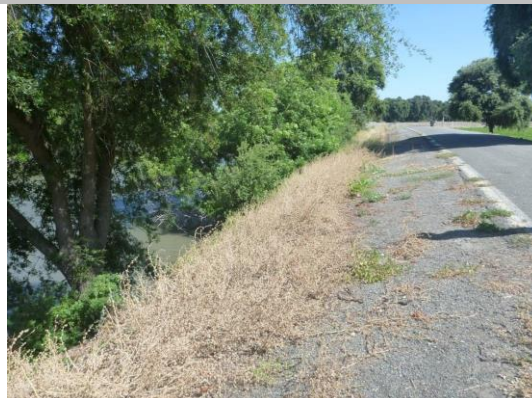
Comment Code					
Inspector Comment					
Levee Evaluation Comments					
Description:On 11 January 2017 and 7 February 2017, waterside instability and erosion were observed on the east (left) bank of Elk Slough. The site is approximately 43 feet long and 11 feet down from the levee crest. See attached pages for photos.					
Site ID No:302					
Site Designation:LMA-128					
Repair Type: Erosion					
Rating:Area of Concern					
Field Date:7/18/2017					
Notes: Erosion on lower 2/3 of slope. Crown is a paved road. Area of concern because erosion was not as severe and there was lots of vegetation on the lower slope indicating damage may be older. WS slope has been rocked just downstream of this site.

Item	2017 Storm Damage			38.364450 °		38.364567 °
				-121.555331 °		-121.555333 °
DWR ID	DWR_RD0150_03_f_2017_91					
Comment Code						
Inspector Comment						
Levee Evaluation Comments						
Description:On 11 January 2017 and 7 February 2017, waterside instability and erosion were observed on the east (left) bank of Elk Slough. The site is approximately 43 feet long and 11 feet down from the levee crest. See attached pages for photos.						
Site ID No:302						
Site Designation:LMA-128						
Repair Type: Erosion						
Rating:Area of Concern						
Field Date:7/18/2017						
Notes: Erosion on lower 2/3 of slope. Crown is a paved road. Area of concern because erosion was not as severe and there was lots of vegetation on the lower slope indicating damage may be older. WS slope has been rocked just downstream of this site.

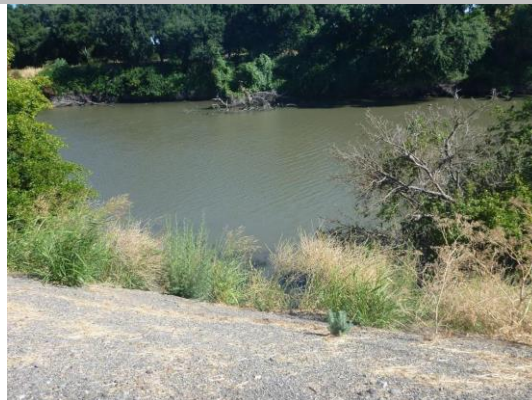
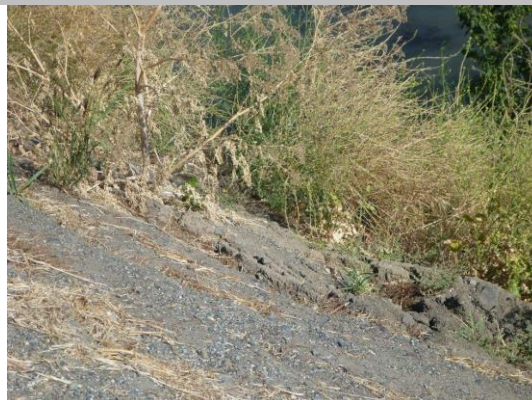
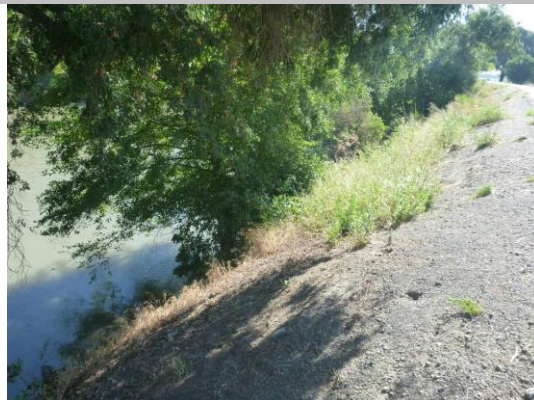
Description: Between 11 and 19 January 2017, waterside instability and erosion were observed on the east (left) bank of Elk Slough. The site is approximately 88 feet long, 7 feet below the levee crest, and includes a fallen tree and exposed root ball in the levee slope. See attached pages for photos.

Notes: Crown is a paved road. Near vertical on lower 1/2 of slope oncluding a fallen tree with exposed root ball. Serious because sloughing cuts into already oversteepened prism significantly and visible longitudinal cracking near crown.

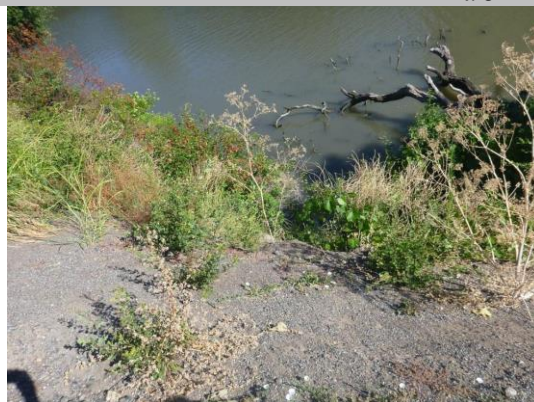
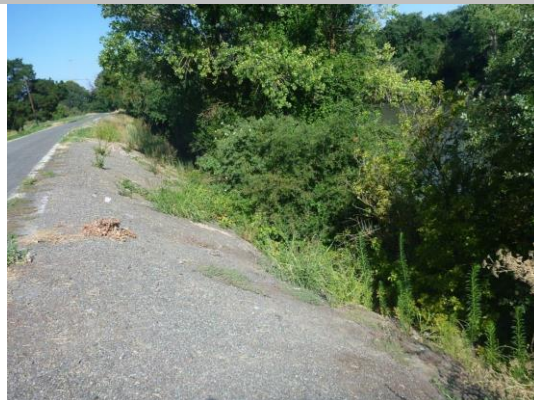
Item	2017 Storm Damage		38.374314 °	38.374344 °								
			-121.547753 °	-121.547447 °								
DWR ID	DWR_RD0150_03_f_2017_108											
Comment Code												
Inspector Comment												
<p>Levee Evaluation Comments</p> <p>Description: Between 11 January 2017 and 7 February 2017, instability, cracking, and erosion of the waterside levee slope were observed on the east (left) bank of Elk Slough. The site is approximately 88 feet long. See attached pages for photos.</p> <p>Site ID No: 305</p> <p>Site Designation: LMA-131</p> <p>Repair Type: Erosion</p> <p>Rating: Serious</p> <p>Field Date: 7/18/2017</p> <p>Notes: Crown is a paved road. Near vertical sloughing on the lower 2/3 of the prism. House and ramp/driveway on the LS. Serious because sloughing cuts into already oversteepened prism significantly.</p>

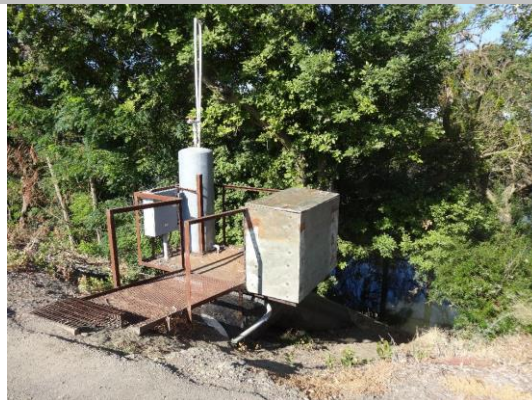
Photo 1 of 3 : UCIP\_FA\_2018\_49386\_63902.jpg

WS view: pipe, steel deck, pressure tank, electric control box on stream bank.

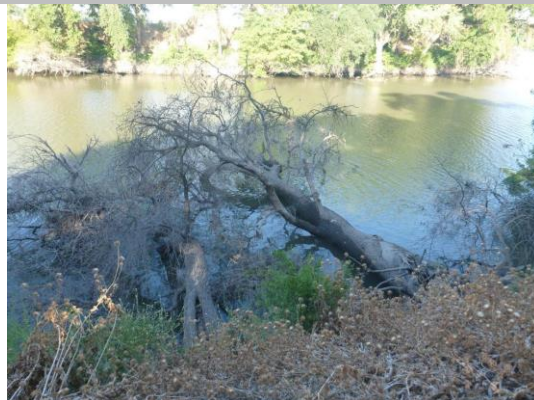
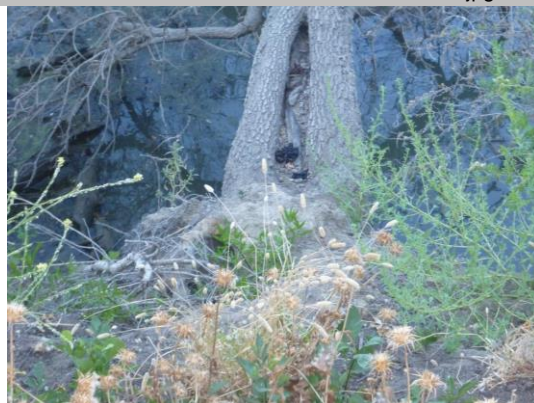
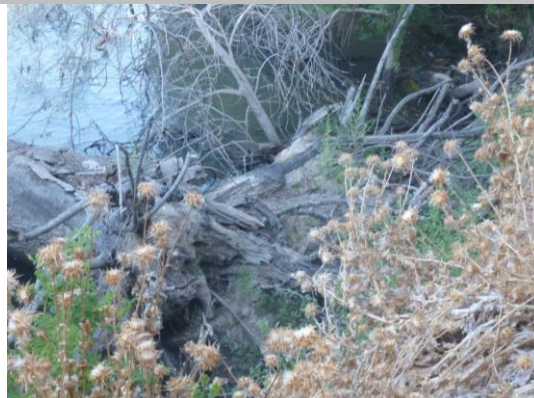
Description: On 19 January 2017, two large trees were observed to have fallen into the water exposing the root ball on the waterside levee slope on the east (left) bank of Elk Slough. The site is approximately 10 feet long. See attached pages for photos.

Notes: 2 oak trees fell over at the WS toe and took root balls out of the lower slope about 5 ft deep just above the water line. Area of concern because damage is only on the lower slope near the water line.

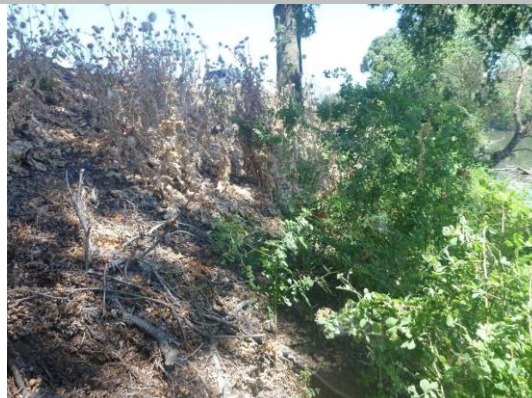
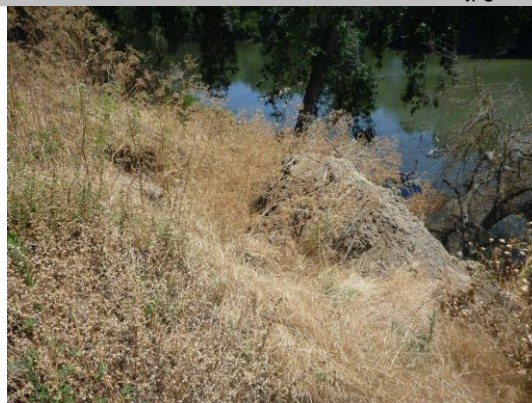
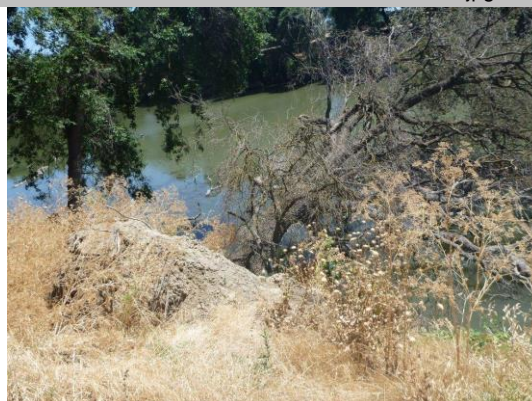
Comment Code					
Inspector Comment					
Levee Evaluation Comments					
Description:Cracking and erosion were observed on the waterside levee slope on the east (left) bank of Elk Slough. The site is approximately 40 feet long. See attached pages for photos.					
Site ID No:310					
Site Designation:LMA-136					
Repair Type: Erosion					
Rating:Serious					
Field Date:7/17/2017					
Notes: Large oak tree fell over here and took a root ball with it. At least 15 ft wide by 5ft deep soil missing, 5 ft from crown. Longitudinal cracks for 40 ft along crown hinge. Serious because prism is impacted and cracking is visible beyond the damaged area.

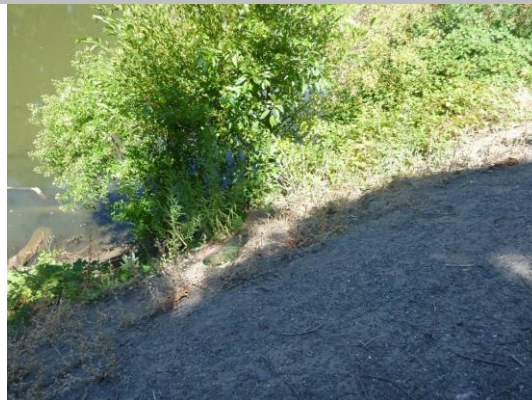
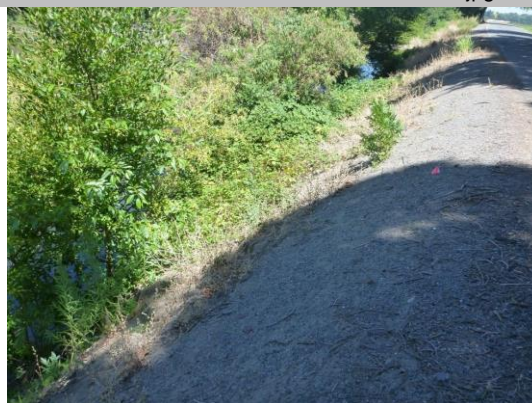
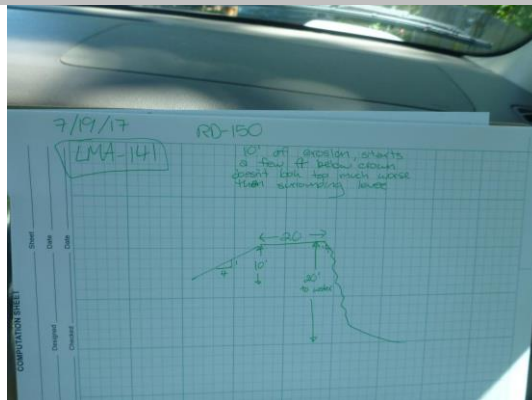
LM Start	<b>6.95</b>	Rating **	A/W	Issue No.	<b>121</b>
LM End	<b>6.95</b>	Issue Type +	Ma	Location *	WS
Category	Supplemental		GPS Latitude/Longitude		
			Start	End	
Item	2017 Storm Damage		38.397197 °	38.397225 °	
			-121.535089 °	-121.535092 °	
DWR ID	DWR_RD0150_03_f_2017_121				
Comment Code					
Inspector Comment					
<p>Levee Evaluation Comments</p> <p>Description: Erosion was observed on the waterside levee slope on the east (left) bank of Elk Slough. The site is approximately 10 feet long and progresses up to the levee crown. See attached pages for photos.</p> <p>Site ID No: 314</p> <p>Site Designation: LMA-141</p> <p>Repair Type: Erosion</p> <p>Rating: Area of Concern</p> <p>Field Date: 7/19/2017</p> <p>Notes: Area of concern because the site is so small and only looks slightly worse than the surrounding levee slope. Crown is a paved road.</p>

Description: Erosion was observed on the waterside levee slope on the east (left) bank of Elk Slough. The site is approximately 10 feet long and progresses up to the levee crown. See attached pages for photos. Site ID No: 314

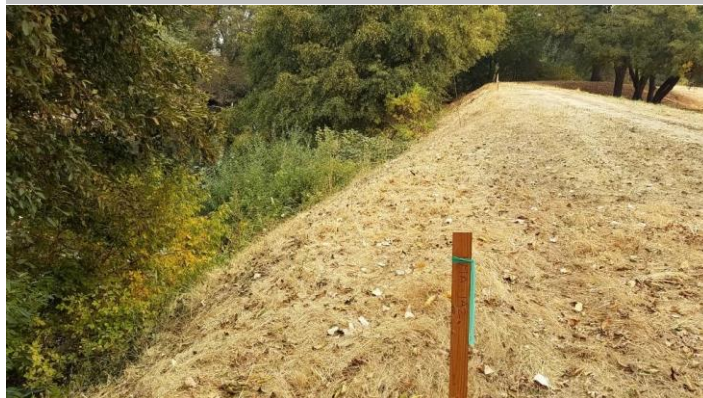
Photo 1 of 4 : FA\_2018\_RD0150\_17\_122\_20181115\_00204.jpg

Description: Erosion was observed on the waterside levee slope on the east (left) bank of Elk Slough. The site is approximately 10 feet long and progresses up to the levee crown. See attached pages for photos. Site ID No: 315

View of waterside slope. Fall 2018

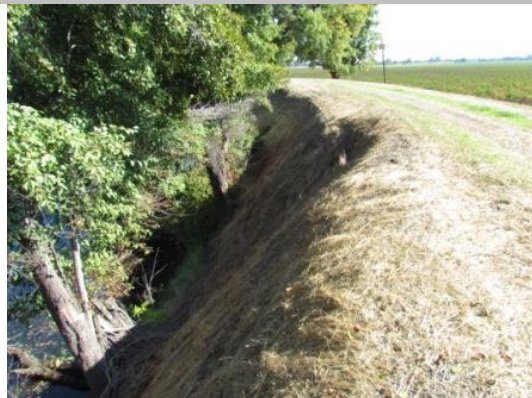
Photo 2 of 2 : FA\_2018\_RD0150\_17\_67\_20180910\_00059.jpg

Erosion was found on the waterside shoulder of the levee looking upstream. This picture was taken during fall 2012 inspection.

LM Start	8.33	Rating **	M	Issue No.	67 (cont)	
LM End	8.33	Issue Type +	Ma	Location *	WS	
Category	Earthen Levee			GPS Latitude/Longitude		
				Start		End
Item	Erosion / Bank Caving			38.407958 °	38.407958 °	
				-121.534583 °	-121.534583 °	
DWR ID	DWR_RD0150_03_s_2012_67					
Comment Code						
E1 : Note and monitor erosion site.						
Inspector Comment

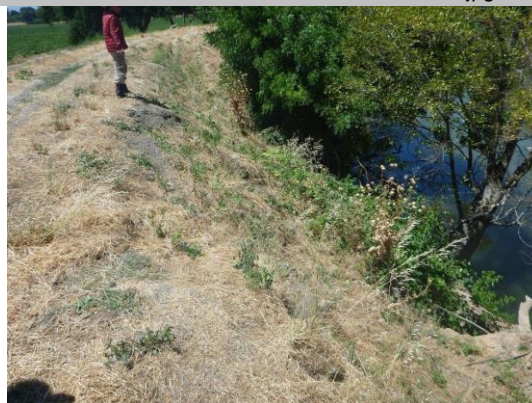
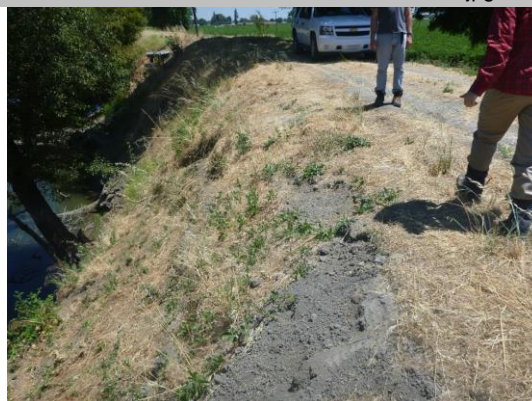
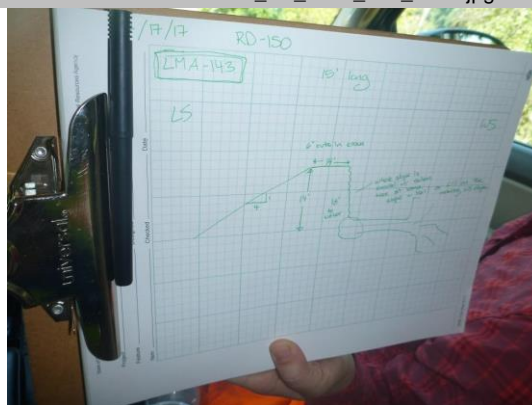
Item	2017 Storm Damage		38.407983 °	38.407992 °	
			-121.534322 °	-121.534289 °	
DWR ID	DWR_RD0150_03_f_2017_123				
Comment Code					
Inspector Comment					
<p>Levee Evaluation Comments</p> <p>Description: Erosion was observed on the waterside levee slope on the east (left) bank of Elk Slough. The site is approximately 10 feet long. See attached pages for photos.</p> <p>Site ID No: 316</p> <p>Site Designation: LMA-143</p> <p>Repair Type: Erosion</p> <p>Rating: Serious</p> <p>Field Date: 7/17/2017</p> <p>Notes: 3 large trees in/adjacent to site including a fallen tree in the middle of the erosion. Erosion on almost the whole slope, but doesn't cut into the crown. Serious because erosion cuts into levee significantly here.</p>
